Manhole Inspection Summary

Manhole # S3100_010MH

Location Address: **2420 SISSON ST**

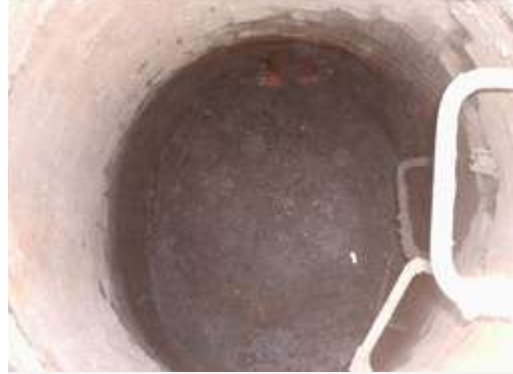
Top View

Corroded steps. Channel debris.

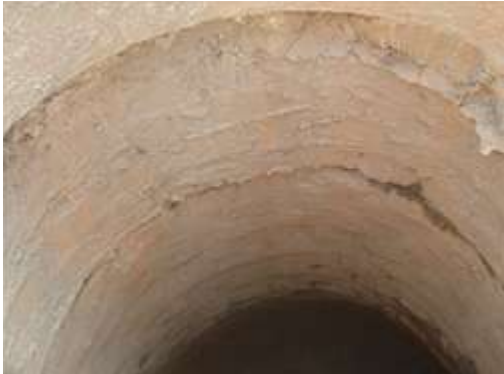
Defect

Frame leaks. Adjustment, Corbel and Barrel infiltration.

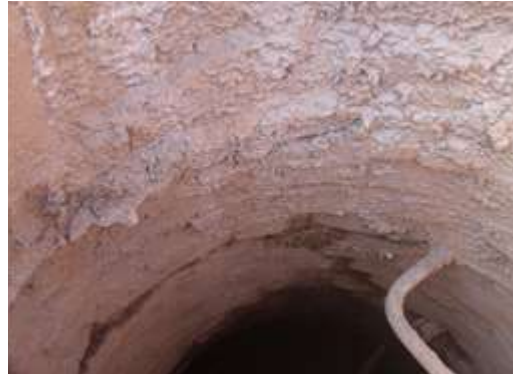
Defect

Frame leaks. Adjustment and Corbel infiltration.

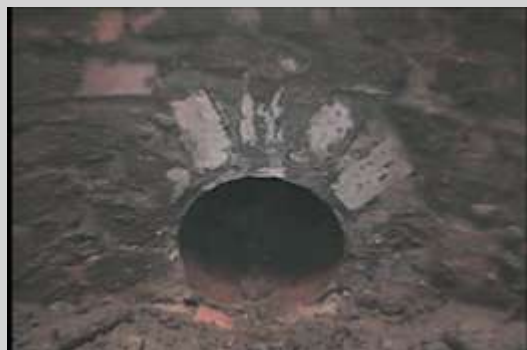
Pipe Out @ 12 O'Clock

Deposits: ☐ None ☒ **Mud** ☐ Sludge ☒ **Debris** ☐ Grease

Deposits Extent: **Light**
